**Surficial Impact Assessments on Mawchi Mine Area**

**Zaw Zaw Thein  
Assistant Geologist  
Department of Geological Survey and Mineral Exploration**

February, 2023

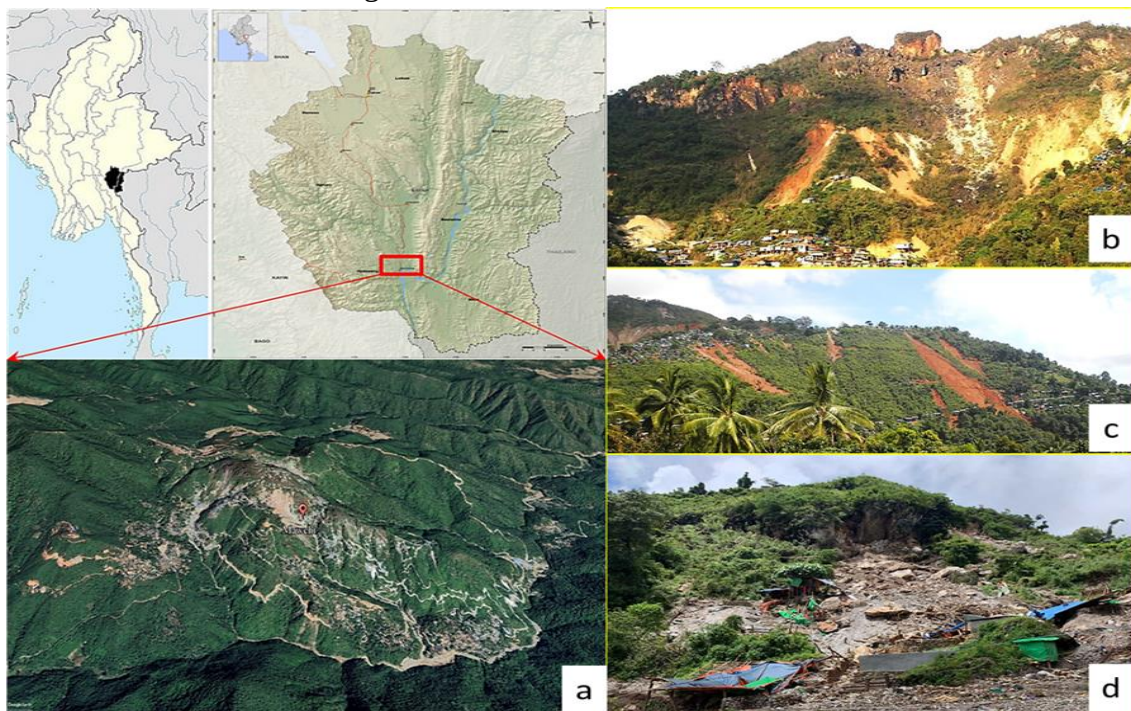
Figure 1. Mawchi mine and landslides (a) Location map of the Mawchi mine area, (b) Two times reported rock fall area 1985, 1988, (c) Shallow landslide occurrences, October 11, 2015 (d) Rock slope failure, October 25, 2019.

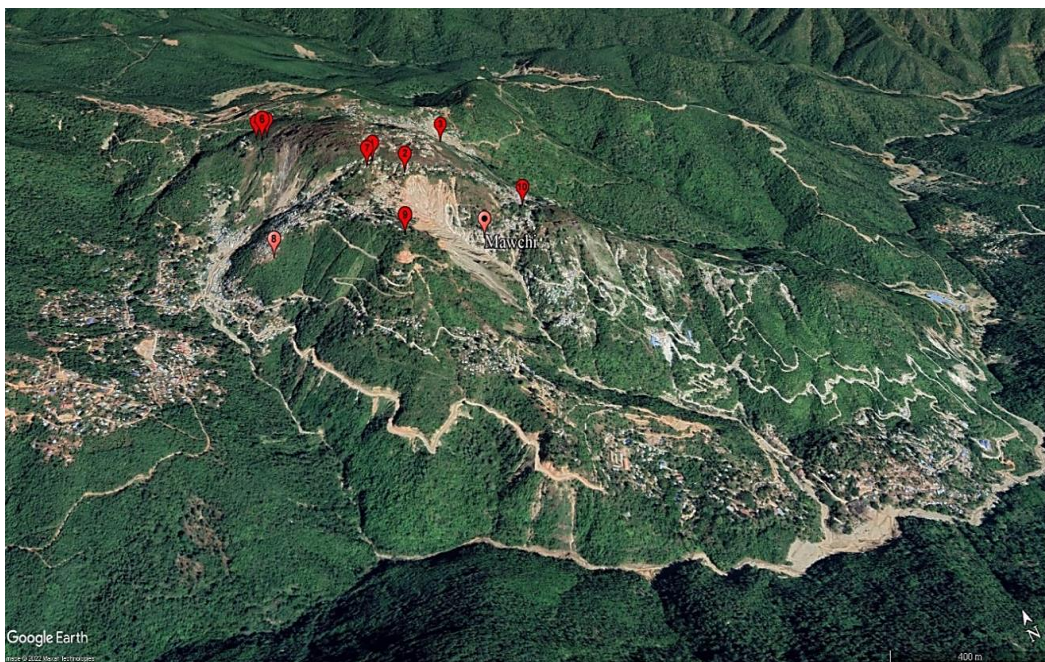
Ten surficial crack sites on both soil and rock areas are recorded as shown in Figure-2 shows the location of crack sites. Cracks size, width and height are measured using a tape. Garmin GPSMAP 64s was used to locate the position of fracture formation and determine the distribution of cracks which are presented in Table 1.

Figure 2. Locations of cracks occurrences in mine area

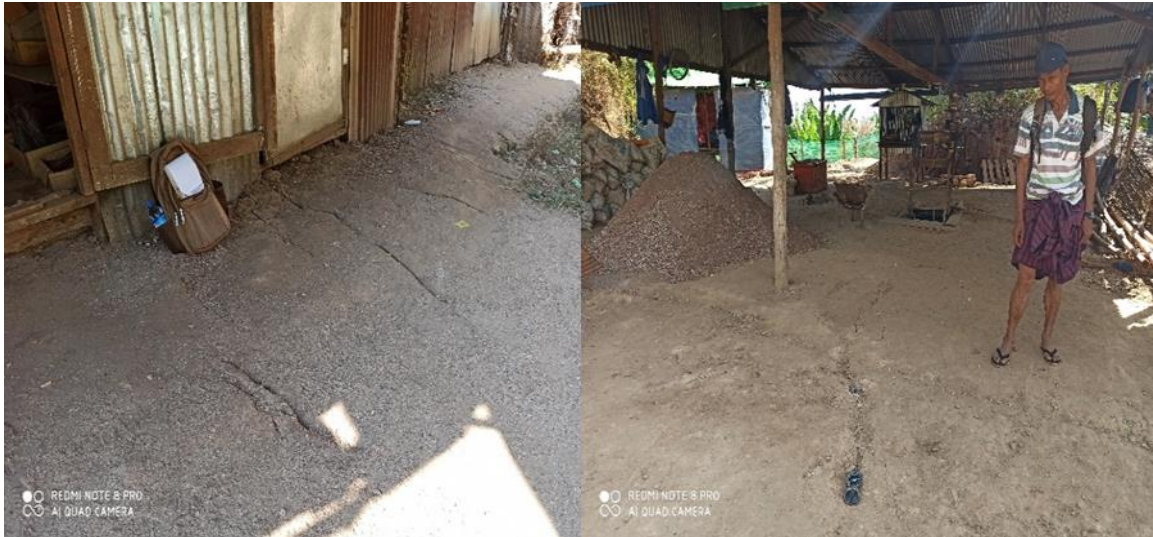
The cracks at No.1, 2 and 7 are located in the Taung-paw village. In No.1, there are four parallel cracks with width of 3-5 cm, the length is more than 15m with  $170^\circ$  alignment and the interval of parallel ranges is 0.3-1m. No.2 is located at the mining site by vertical shaft. The visible width of crack is 10cm and no step is seen. The length of crack is about more than 30m, its alignment is  $110^\circ$  and direction may be SW. No.7 crack is a step crack with the width of 5-7 cm, step height about 10cm,  $40^\circ$  alignment and SE direction. These crack sites are large noticeable relevant to the subsidence 1 and 2.

The rest of sites, cracks are formed in soil formations especially in colluvium deposit, the tensile cracks (No. 1, 2) are observed and some are found as step cracks (No. 3, 7, 8, 9, and 10). The formation of surface cracks exhibit both crack width and step height, the sizes of which are proportional to the magnitudes of the horizontal stretching (tensile) and vertical movement (shear), respectively. All these cracks are initial signs of slope failures. The application of ore processing mining method especially washing with water and improper mine design underground mining are the induced factors to initiate those crack signs and turn into instability of slope.

Figure 3. Tensile cracks in site No.1 (left) and site No.2 (right)

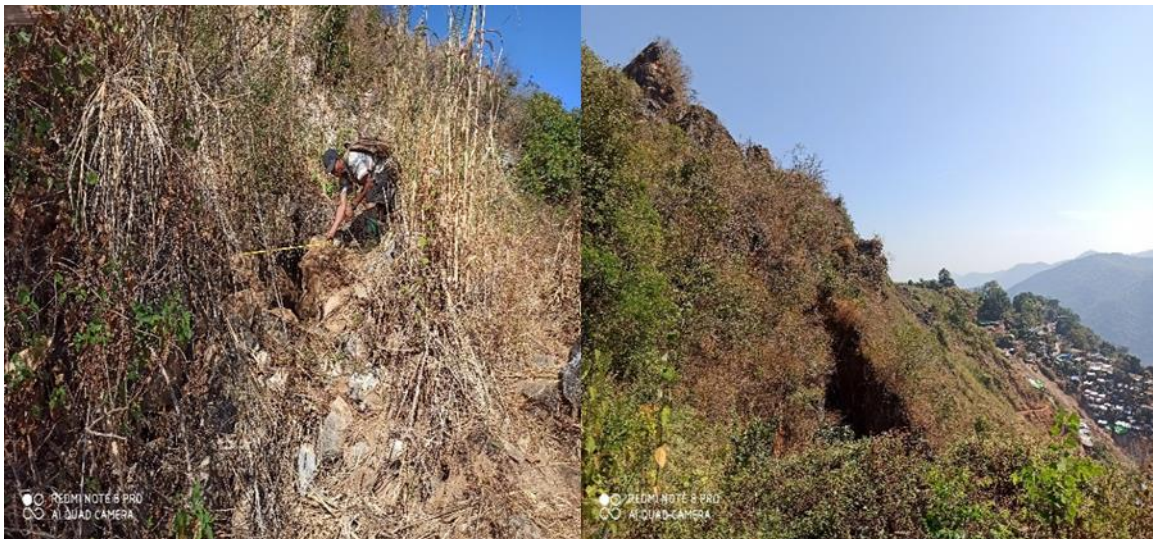
The crack at No.3 is located near KB-1 landslide site. The width of crack is 2m, 30m length and crack alignment is  $310^\circ$  with  $40^\circ$ NE direction.

The cracks at No.4, 5, 6 are located at the Taung-paw Pagoda. It is a group of cracks and connected each other by offset, mainly distributed on the top of western part of Machihill. There is considerable close to the previous rock fall site, where large slope failure occurred since 1985 and 1988. It is indicated that dangerous level for rock fall site.

The sites No. 4, 5 and 6 are open cracks with the size 2-3m width and 10-50m length in limestone formation; mineralization is formed in the discontinuities as soft filling and the extraction of ore were observed in the current survey. The depth of cracks cannot identify. The two main adits, 2-west and 3-west are driving towards these cracks slope. Therefore, the main factors contributing to serious cracks can respectively be considered as both geometric condition of ore mineralization and its extraction. The steep slope is also a controlling factor to induce more serious damage.

Figure 4. Step crack in site No.3 (left) and open crack in site No.4 (right)

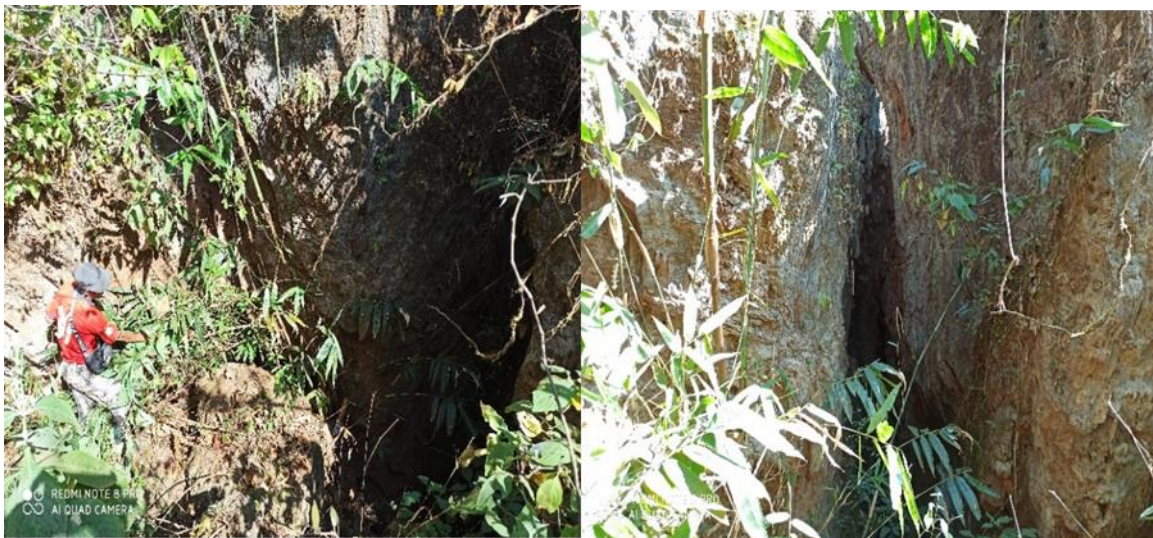
This area is mostly controlled by geological structures where hydrothermal intrusion was taken place. After extraction of ores from those veins cause loss of filling in discontinuities and become open joints on the slope. Those open joints attract the running water /rain water that affect the stability of the slope. That fact also will reduce rating values of rock mass quality and again decrease slope mass stability.

Figure 5. Open cracks in site No.5

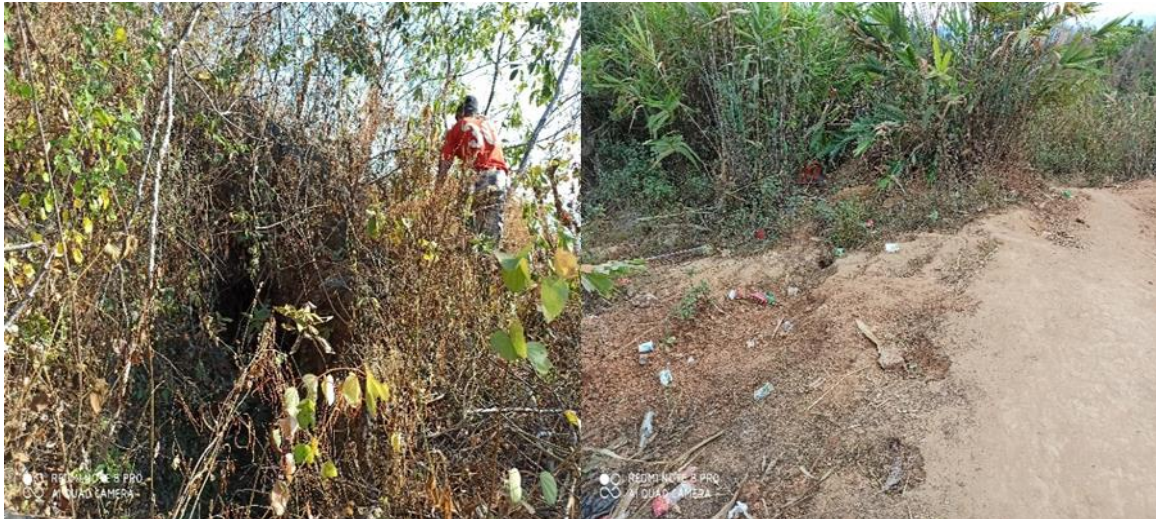
Figure 6. Open crack in site No.6 (Left) and step crack in site No.7

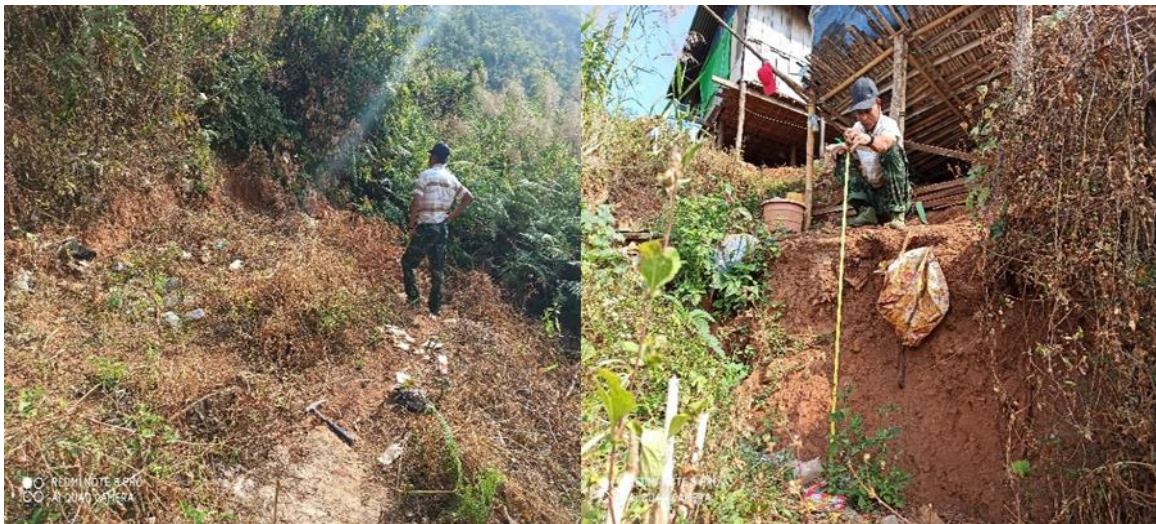
The cracks at No.8 are located at the Yadanar Aung Myay village, three cracks are recorded in which two are step cracks with the heights about 1-1.5m and another crack is about 15m length and width of range is 5-10cm. All cracks are SW direction alignment.

Figure 7. Both tensile crack (left) and step crack (right) in site No.8

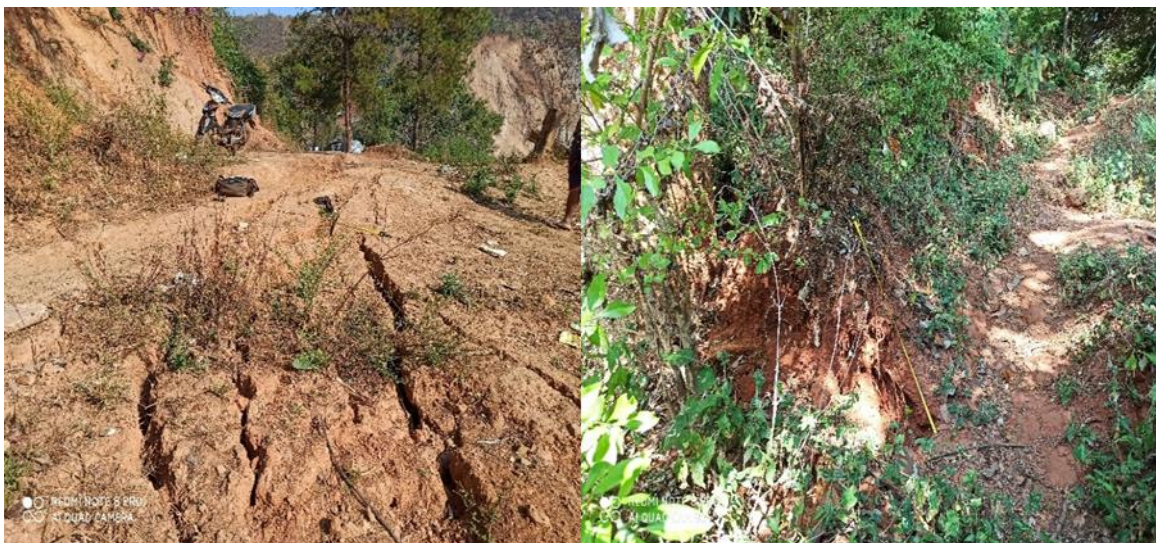
The cracks at No.9 are located at the head of Tin-Villa Bungalow landslide, east of Mawchi hill. There are three separate locations are noted. Two step cracks are with the heights of 1.5-3m with NE direction and another crack is 5-10cm height with SE direction.

Figure 8. Step cracks in site No.9

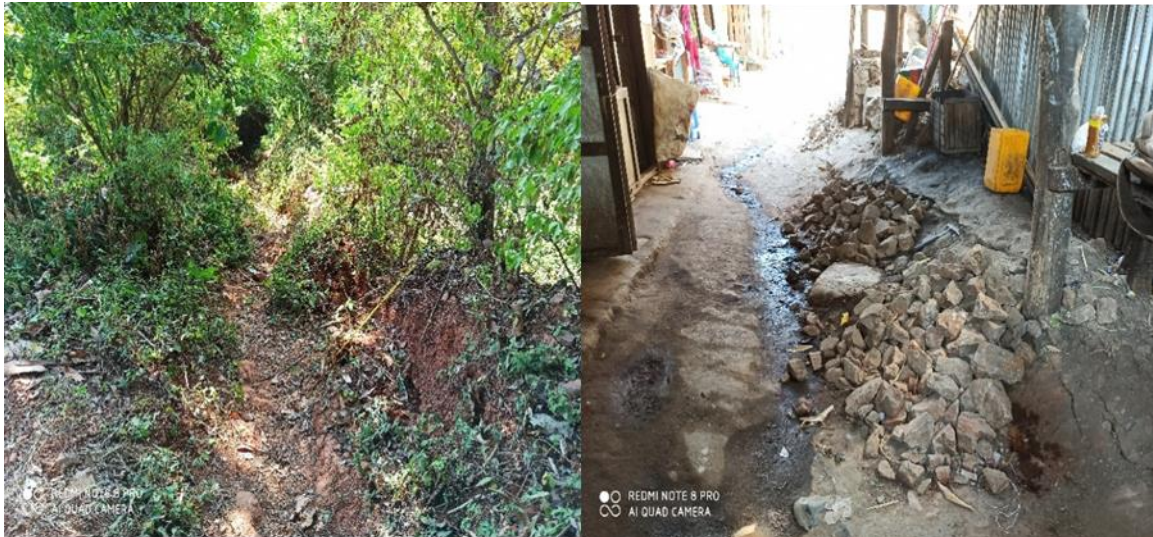
The crack at No.10 is located at the Yukawkho village. It is a step crack with the width of 30 cm, the step height of 30cm and the crack length is 50m. It happened in residential area.

Figure 9. Step cracks in site No.9 (left) and site No.10 (right)

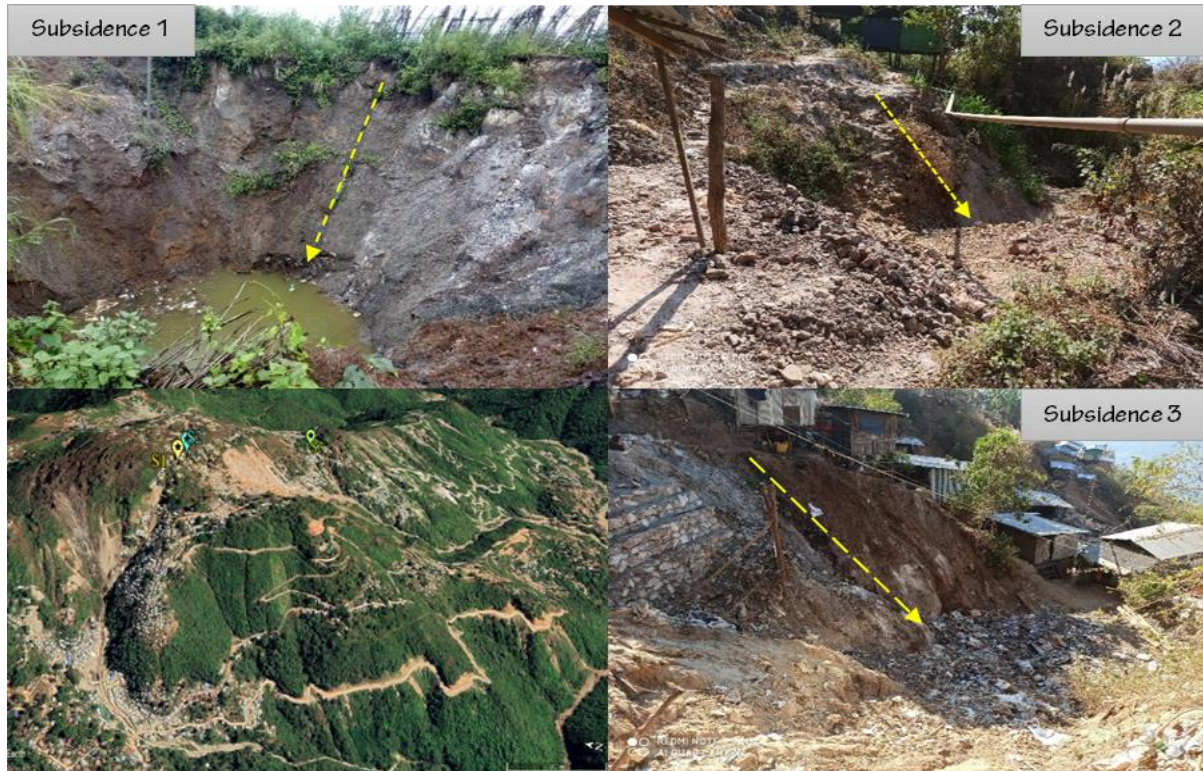
The overlying strata gradually collapsed with the continuous progress of the work face. In the study area, three subsidence centers named S-1, S-2 and S-3 are observed. S-1 and S-2 were formed in Taung-paw village in 2017. S-3 is existed in 13-Gone hill. Subsidence S-1 developed rapidly and eventually sank to the depth of 5m depth in a few days and the S-2 also developed to the depth of 7m depth. The diameter of S-1 is about 30m and S-2 is about 25m in diameter. It is noticed that the rate of deformation slowed down and entered a slow progress in condition. The S-1 was happened on the sloping ground and S-2 is formed in flat area, where abundant underground mining work sites about more than 30 work sites (shaft, adit) around its environs are recorded. S-3 was occurred on slopping ground, near the 13-Gone old landslide. Its diameter is about 15m, the depth is 10m and happened in 2018. All the three sinking were occurred in overburden soil deposit overlies on sandstone and limestone. The following Table-2 shows the locations of those three subsidences.

Figure 10 Three subsidence failure events of the study area

In the study area, some collapse and three subsidences were recorded. Collapse and subsidence conditions are sourced from underground mining activities constitute very important problems. It is noticed that the rate of deformation is slow and entered an active progress in failure condition.

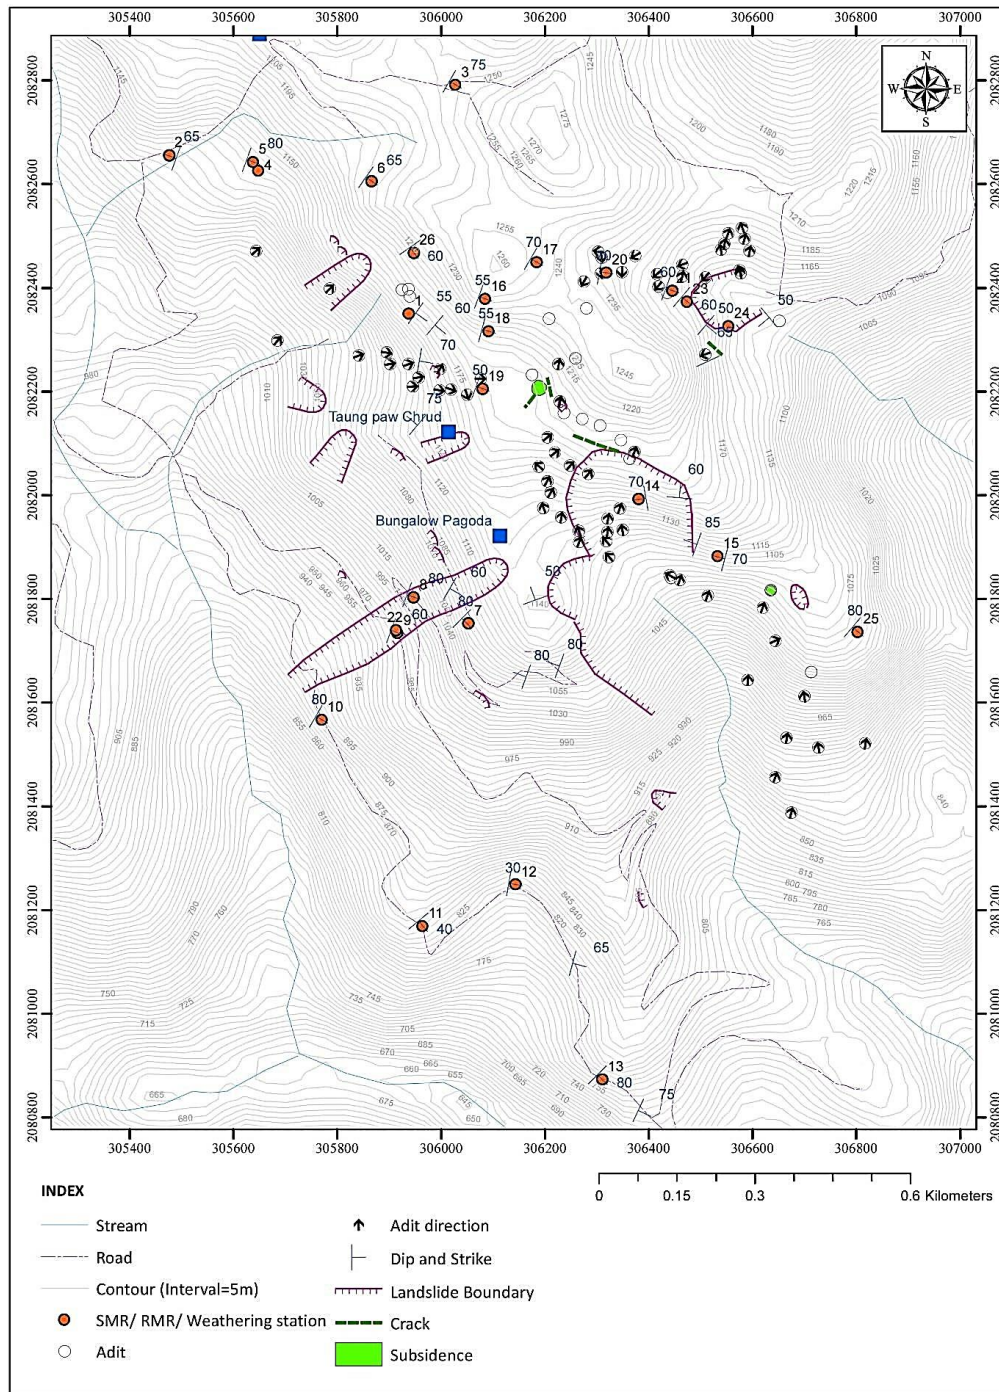
Many of slope deformations are occurred in study area. The previous and current slope deformations are listed in Table-3. There are two types of slope deformations, land sliding in soil formation and rock fall hazard favorable in structurally controlled rock slopes.

According to Figure-11, it is also clear that the directions of current adits are closely related and incubate to cracks, landslides and subsidence. Overburden deformation has a considerable influence on slope stability during underground mining works. Removal of the material by underground mining can create environmental problems and safety hazards.

Figure 11. Slope deformations map of the study area

Many of slope deformations are related to the consequences of operation, drive and mining work that incubate to cracks, landslides and subsidence. Therefore, steps should be taken in safety mining operations to minimize impacts on all aspects of the environment. Periodic inspections of the mine site, training and review of the mining operations will all lead to a safer work environment. Further study, including a detail investigation, is recommended to be conducted by the professionals to assess this potential risk.
