**Development of Ground Fissures a Case Study on Mayogon and  
Poepaukzu Villages, Pwintbyu Township, Magaway Region**

Zaw Zaw Thein, Zaw Htoo Naing, Zwe Pyae Maung  
Department of Geological Survey and Mineral Exploration-DGSE

**December 2021**

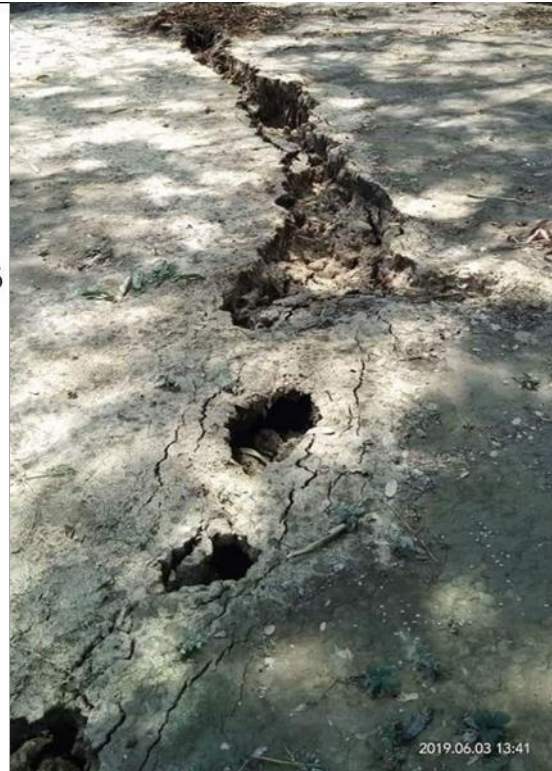
Figure 2. Update news and earth fissure photo reported on social media Facebook

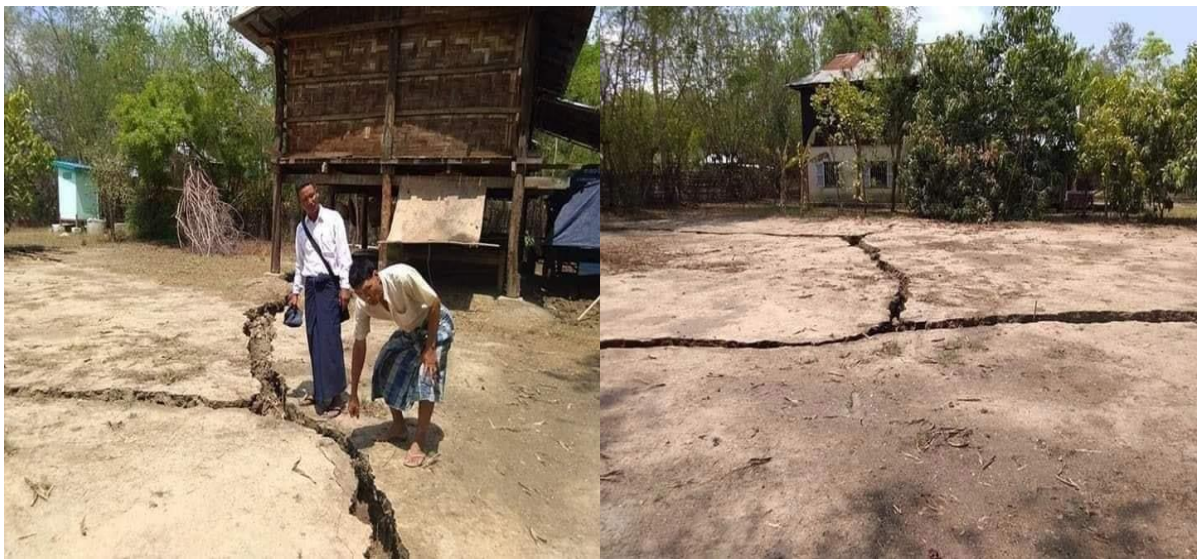
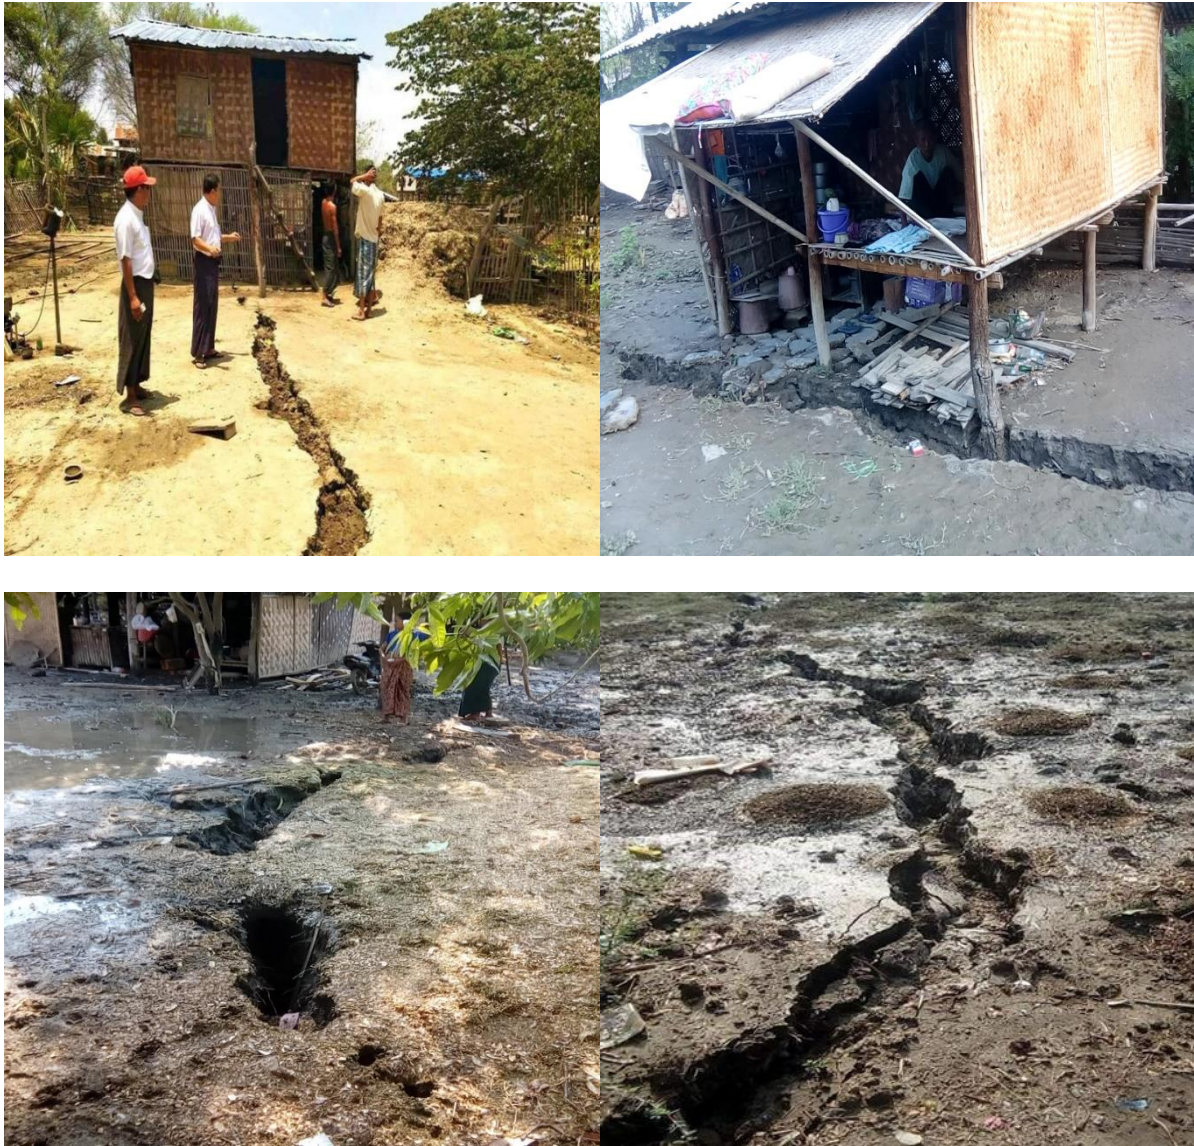
Figure 3. Some earth fissures photos reported on the social media Facebook

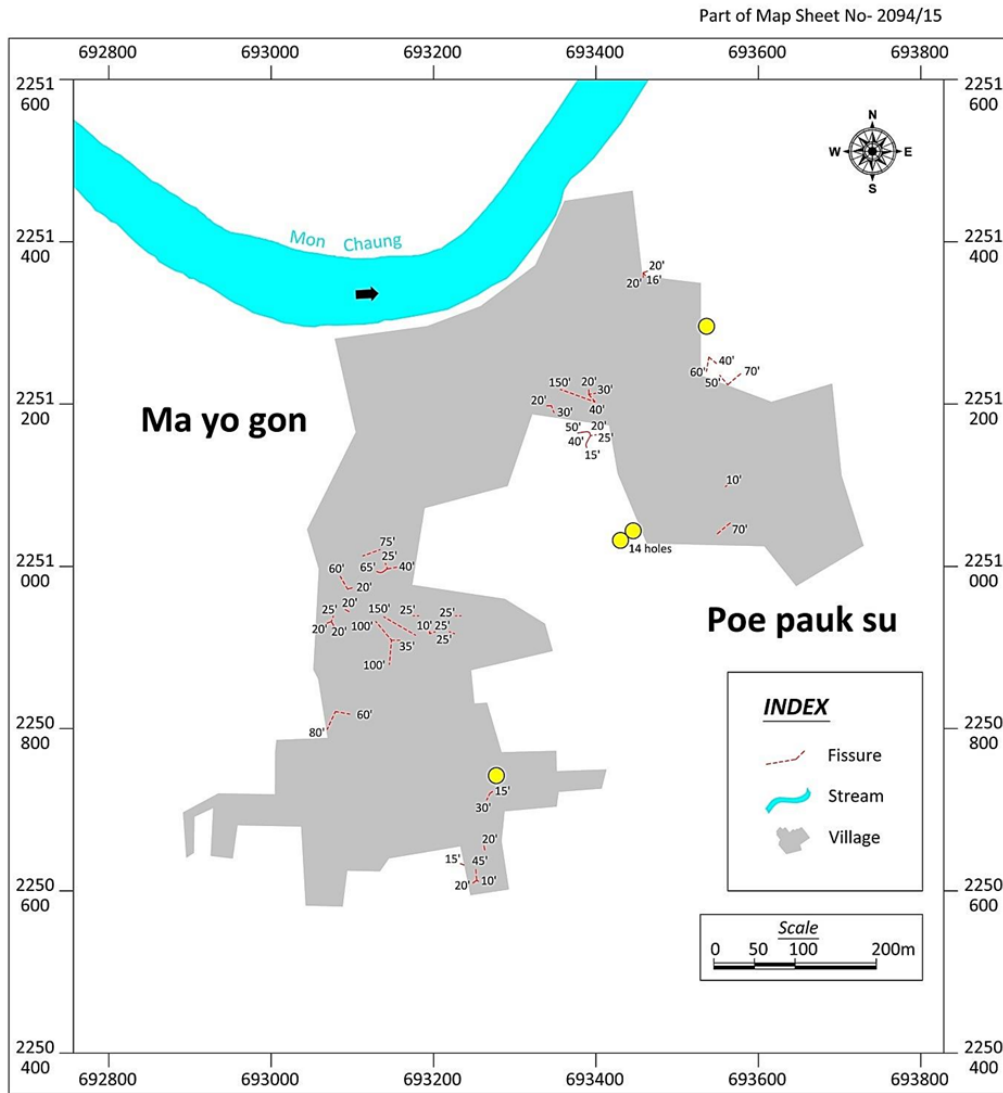
Figure 8. Formation of earth fissures occurrences in study area

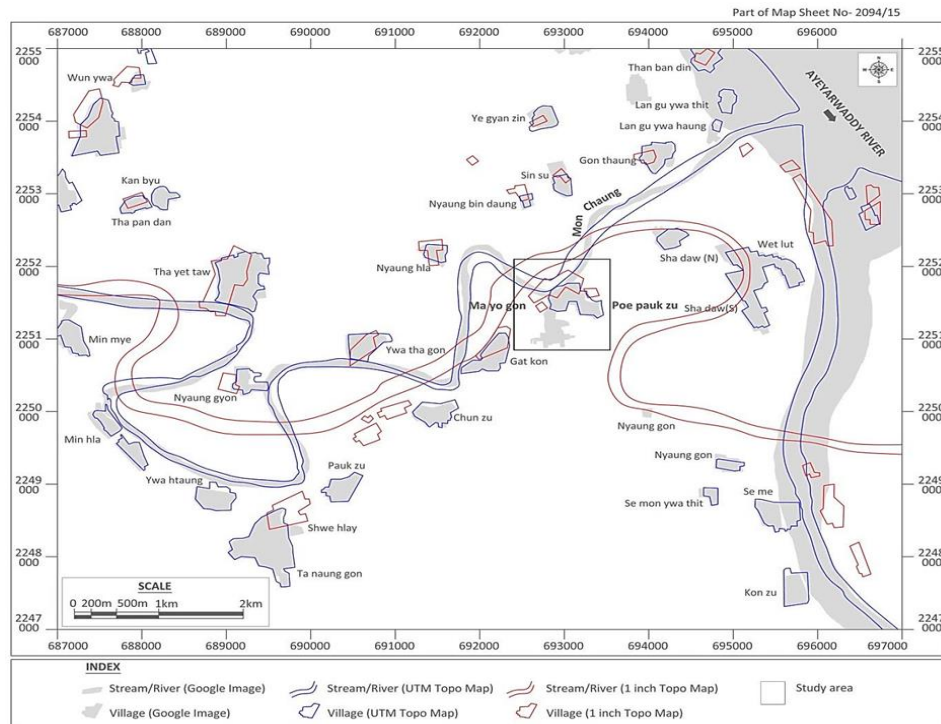
The study area has been subjected to land-use changes over the past few decades for regarding agricultural activities and residential expansion. In fact, the annual erosion of Mon stream channelization is main factor. We used GIS techniques to delineate the changes of stream modification that entirely took place in the study area. In the current paper, we prepared a detailed land-use changes map by interpreting satellite image, one inch to one mile scale topographic map and 1: 50000 meters scale UTM map making field investigations. The data were essential in developing of different maps to determine land-use changes over past time periods. Actually, the northern part of the villages (Mayogone, Poepaukzu, Gat Kon) near Mon stream were gradually displaced in southern part. Nowadays, the northern portions of three villages were entirely disappeared by stream erosions. It is the one considerable item for hydrological study because the groundwater of newer residence land will be produced in extremely extraction short time period for domestic consumptions. Obviously, the stream modification of Mon stream is directly proportional to the land use changes of study area and will be related to the future geological hazard. Therefore, the land use planning of study area and the stream channel training are essentially needed by officially.

Figure 12. Land use changes map of study area

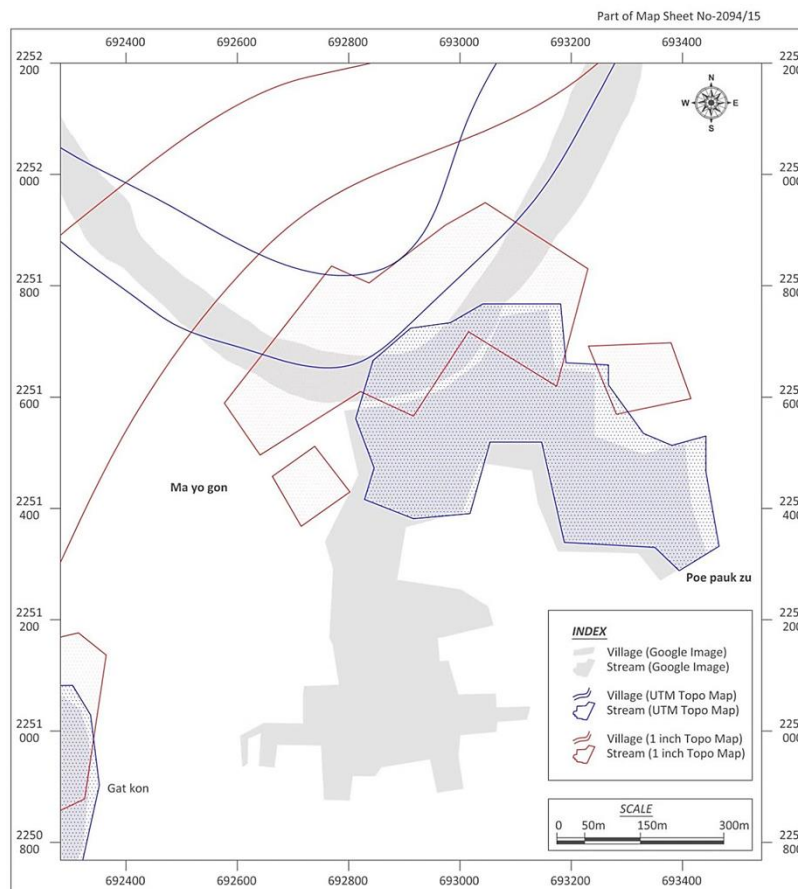
Figure 13. Detail land use changes map of Mayogon & Poepaukzu villages. The light grey color is referred to the current residential area

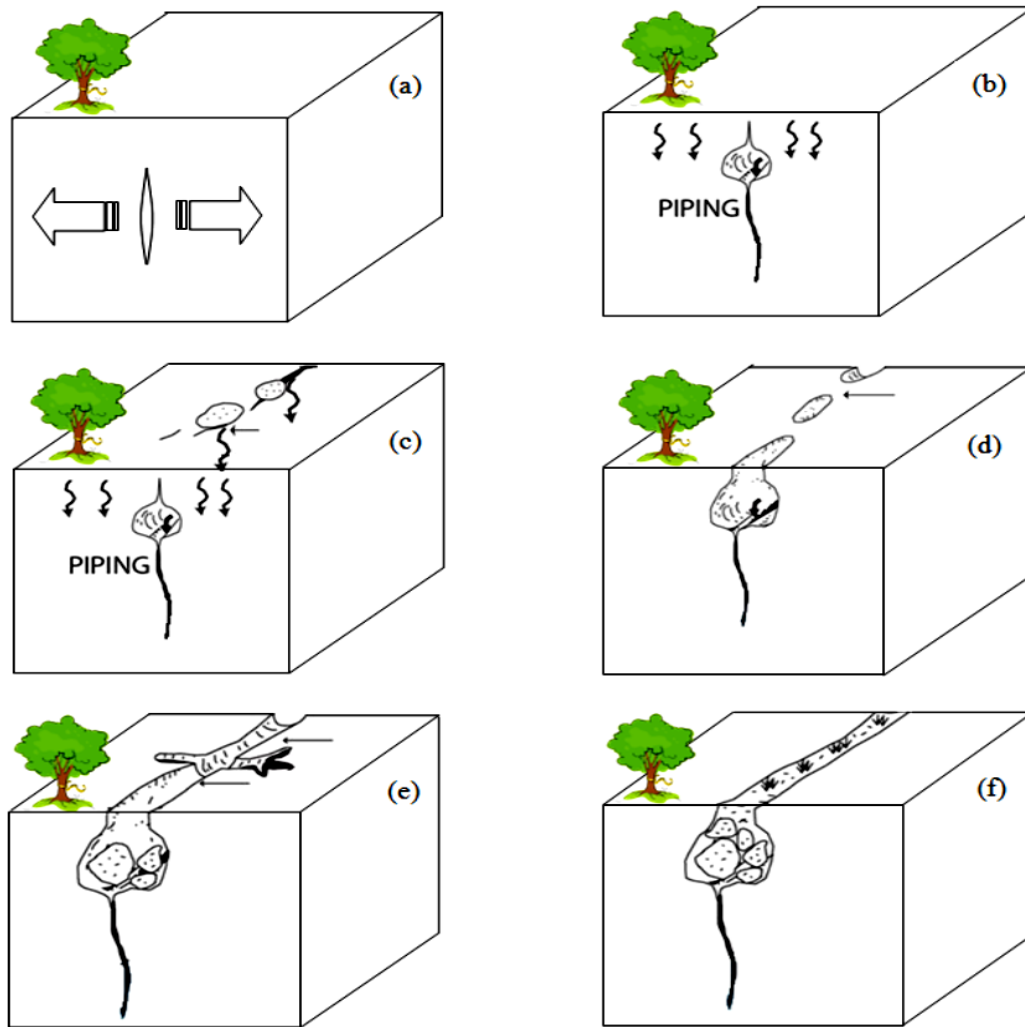
Soil behaviors are one of the most controlling principal factors for formations of earth fissures, especially due to the tensile stress of soil. Tensile stresses within the soil mass may initiate earth fissure. The earth fissure may extend to the ground surface. We used this suggestion to explain fissure gullies observed in study area. It is theorized that surface run off and infiltration opens and deepens the tension crack, forming cavities with deep thin cracks as tails. Further water infiltration causes the roof of the cavities to collapse, forming potholes. Additional infiltration increases piping, causing the linking of the potholes, which results in collapse, as shown in Figure (14). This mechanism for the growth of the earth fissures due to piping is nearly identical to the mechanism proposed study area. In this mechanism, it is unclear how the tensile stresses originate from groundwater pumping and groundwater elevation change. Also, it is unclear where the eroded sediments go. In study area, many earth fissures show no evidence that they are linked to any drainage basin such as washes to receive any material eroded by piping.

Figure 14. Idealized mechanism for the growth of the earth fissures

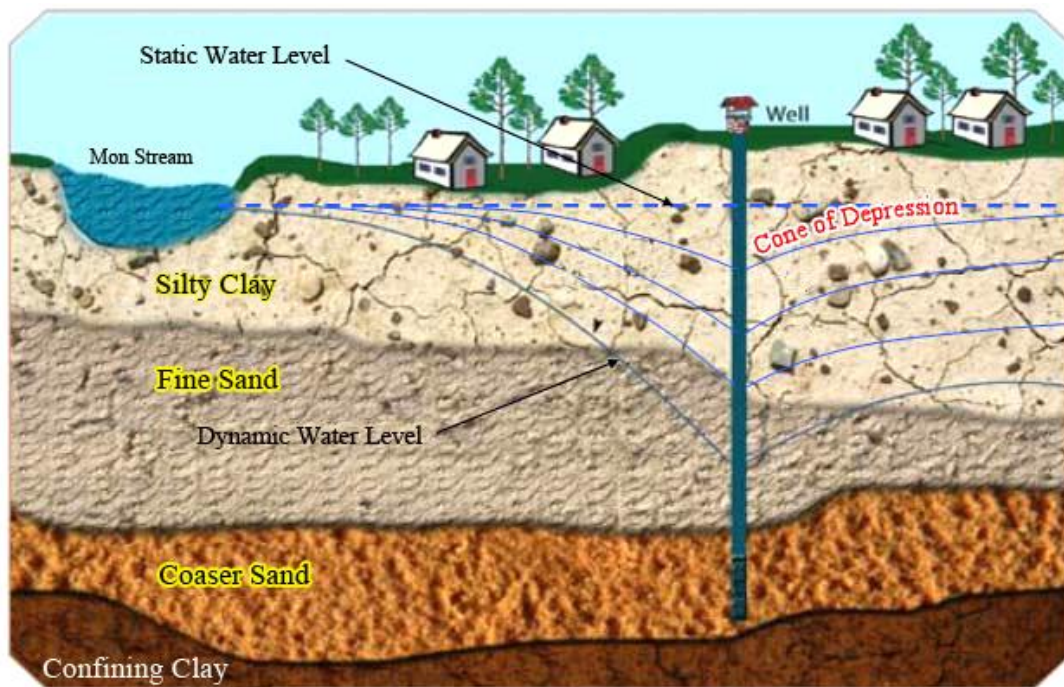
Theoretically, when groundwater is pumped from an unconfined aquifer in the soil, a groundwater cone of depression is formed around the well. The size and shape of the cone of depression depends on many factors, such as the pumping rate, the type of aquifer

material, the amount of water in storage and the thickness of the aquifer. The shape of the cone of depression automatically leads to differential settlement. More settlement is expected near the well than further away from it.

Figure 15. Idealized sketch photo of decline of ground water level by cone of depression

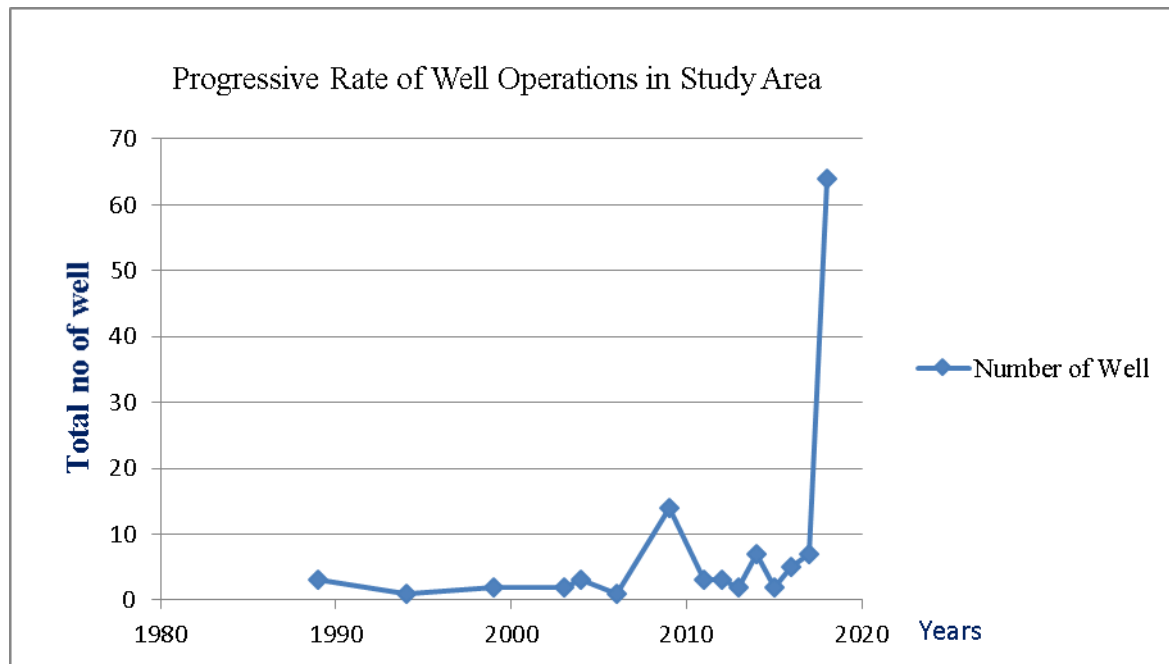
Based on the wells investigation of the study area, the pumping rates of groundwater were significant in the last two years because the machinery pumping is more popular than manual hand pumping. According to this fact leads to the formation of earth fissures and that statement will be completely satisfying for the whole investigation.

Figure 18. Evaluation chart for progressive rate of operation wells in study area from 1980-2019

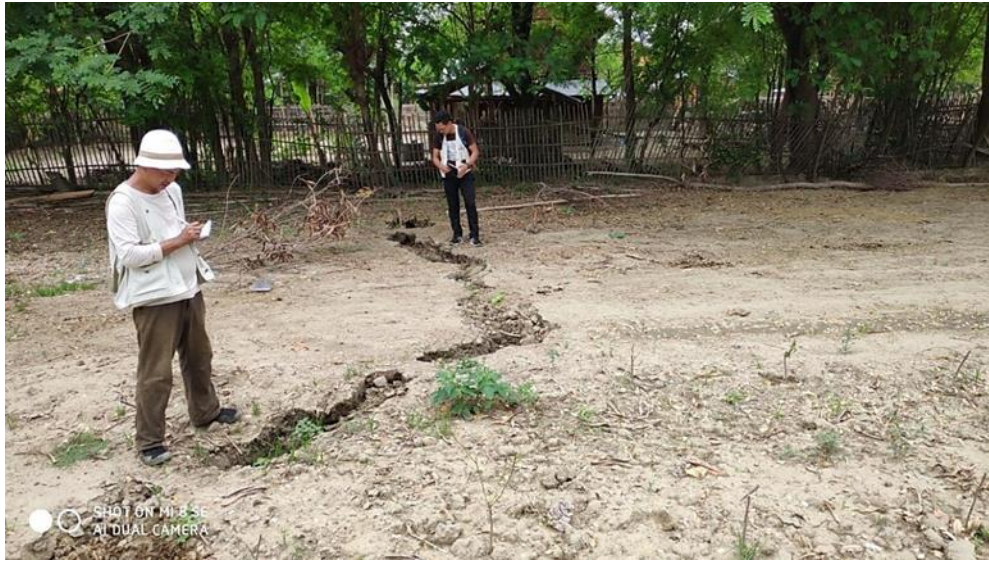
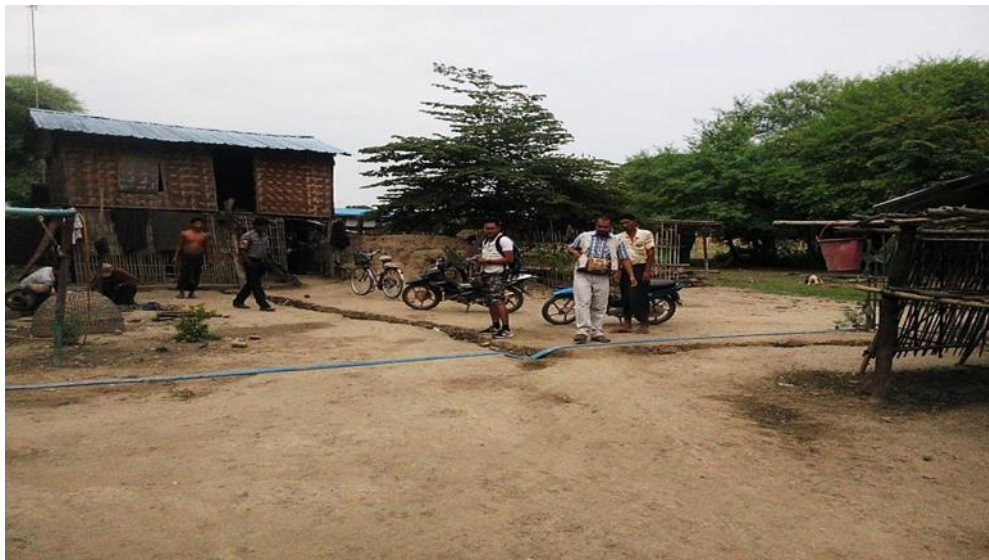
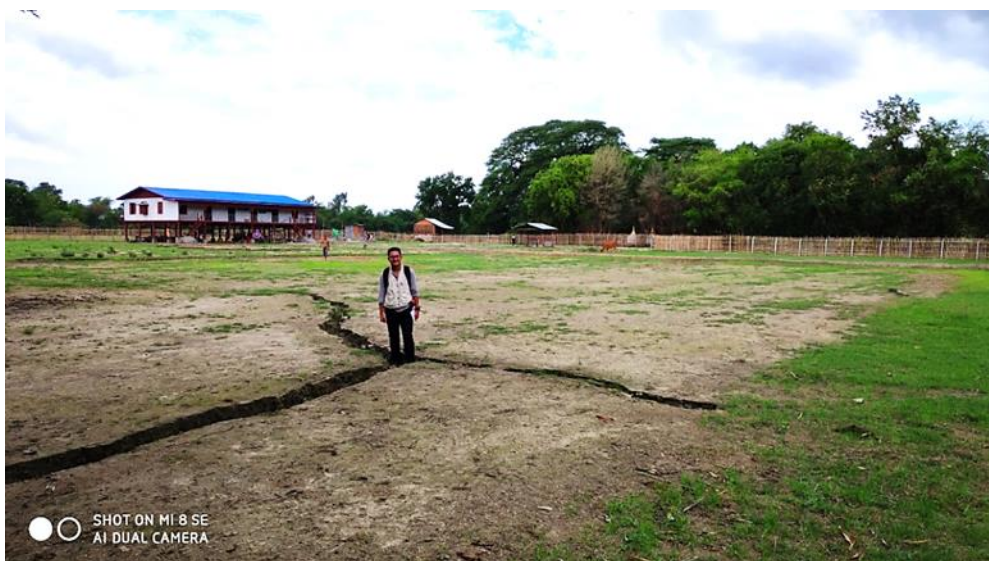
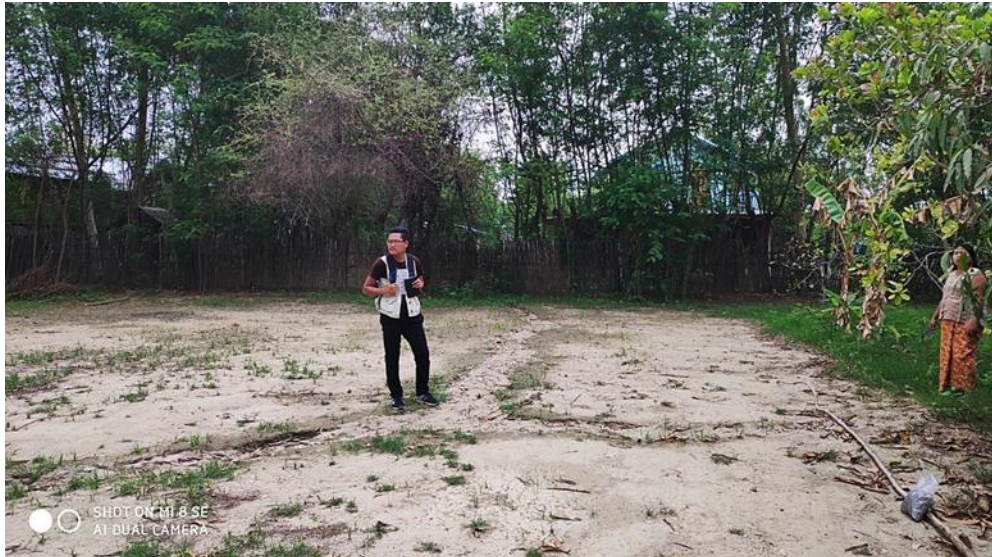
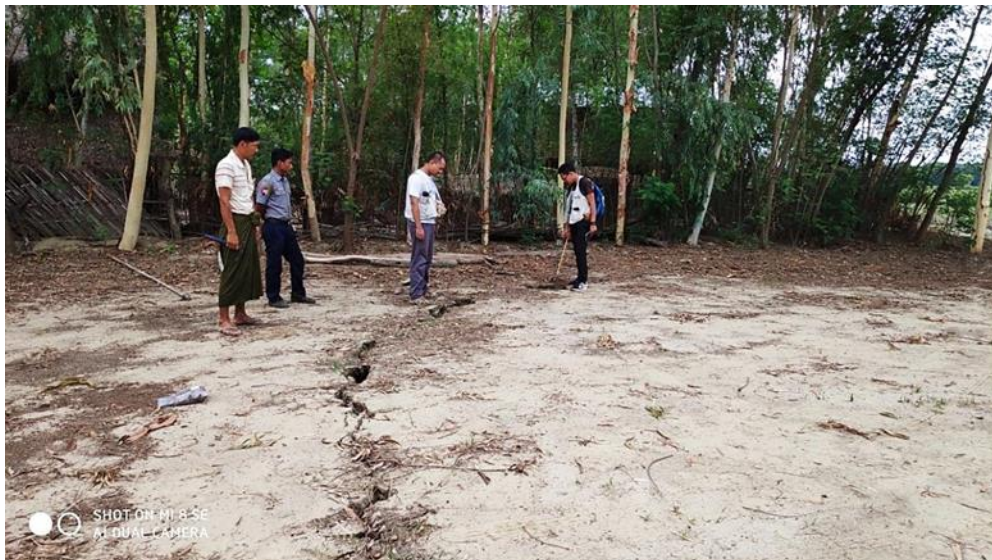
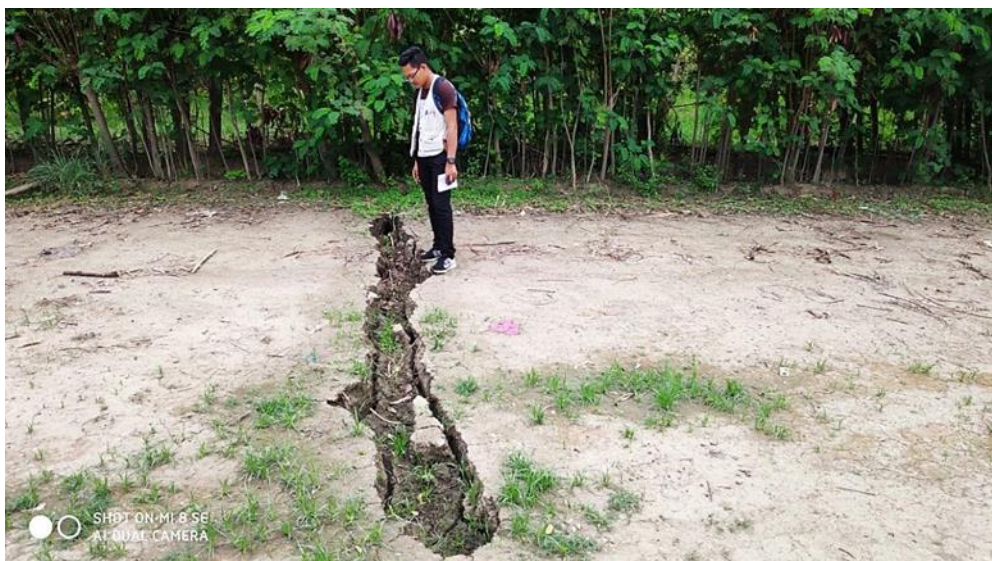
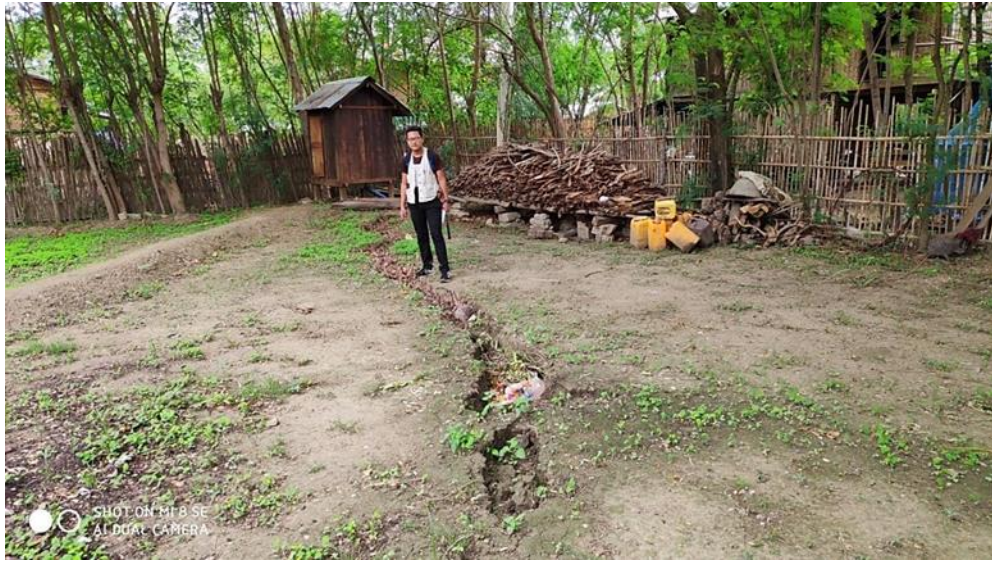
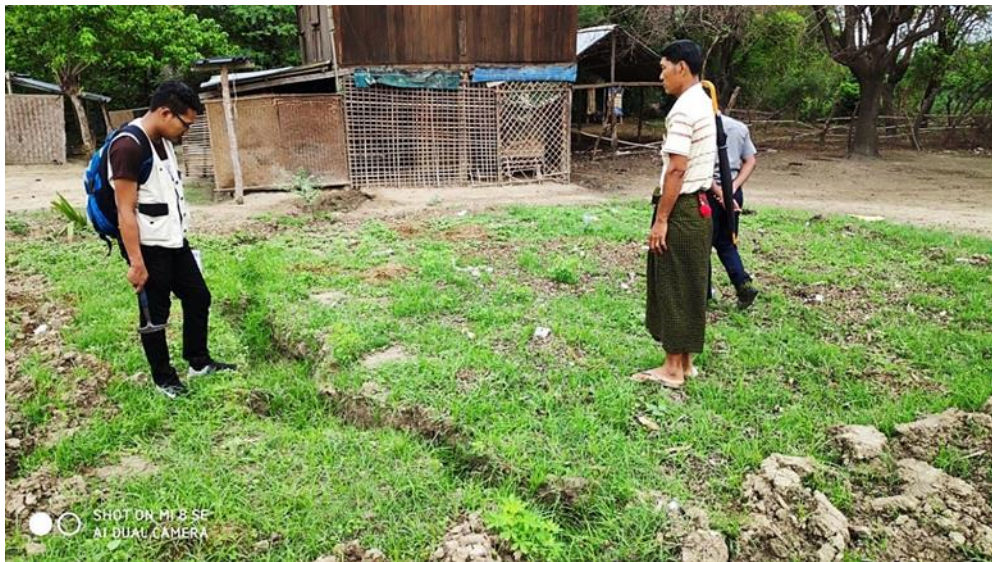
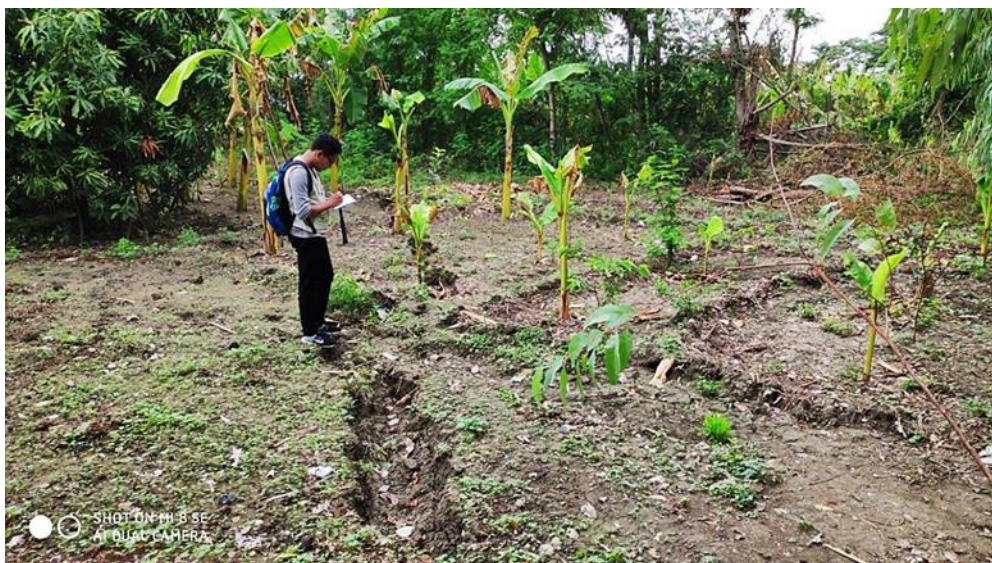
Appendix 1    Surficial expression photos of earth fissure in the study area

Artificial filling of earth fissures with earth materials has no lasting effect upon them. They simply reopen with time.

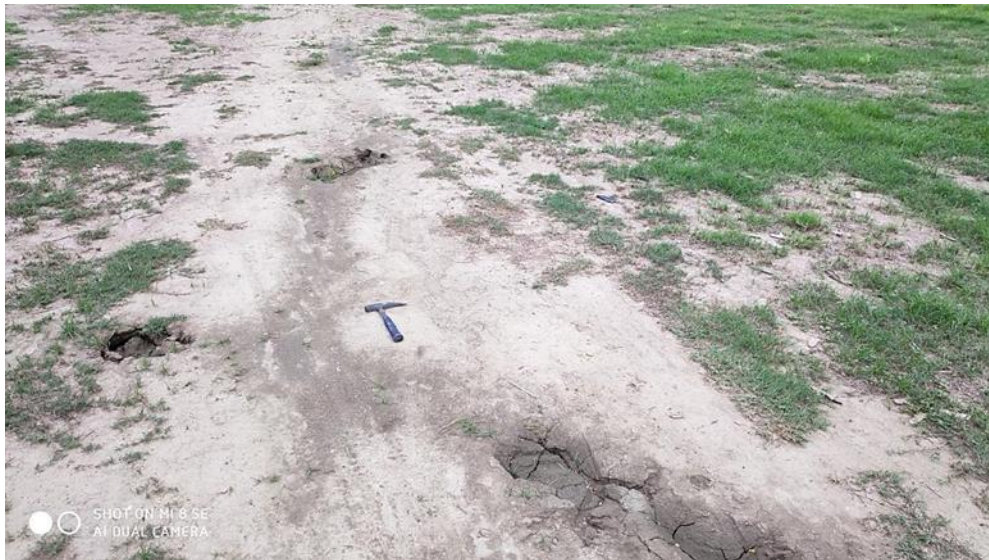
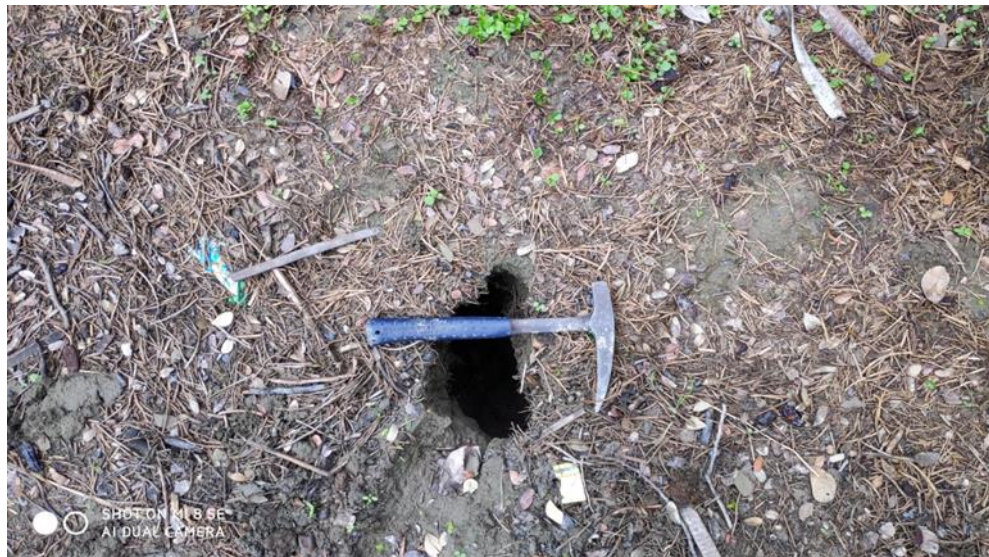
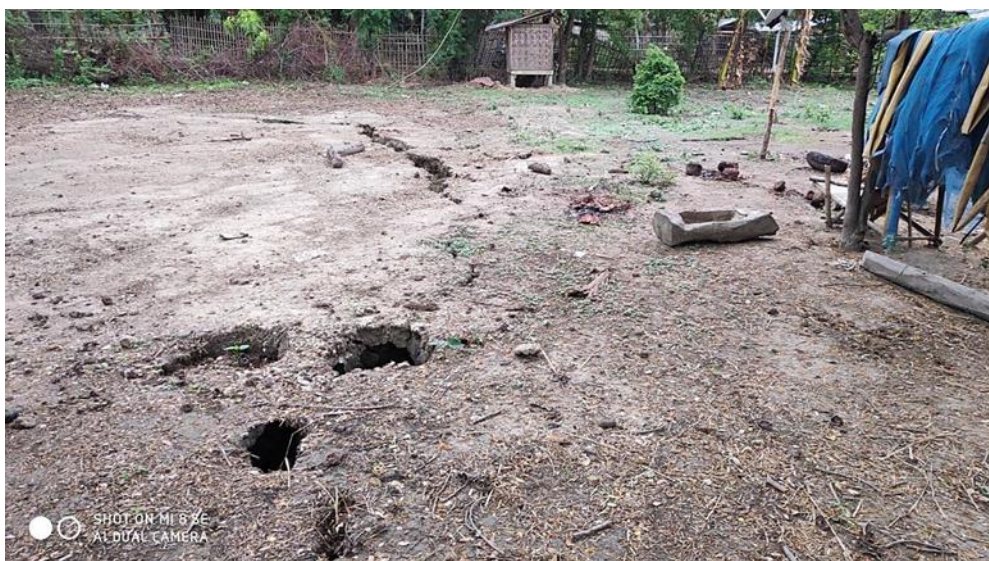
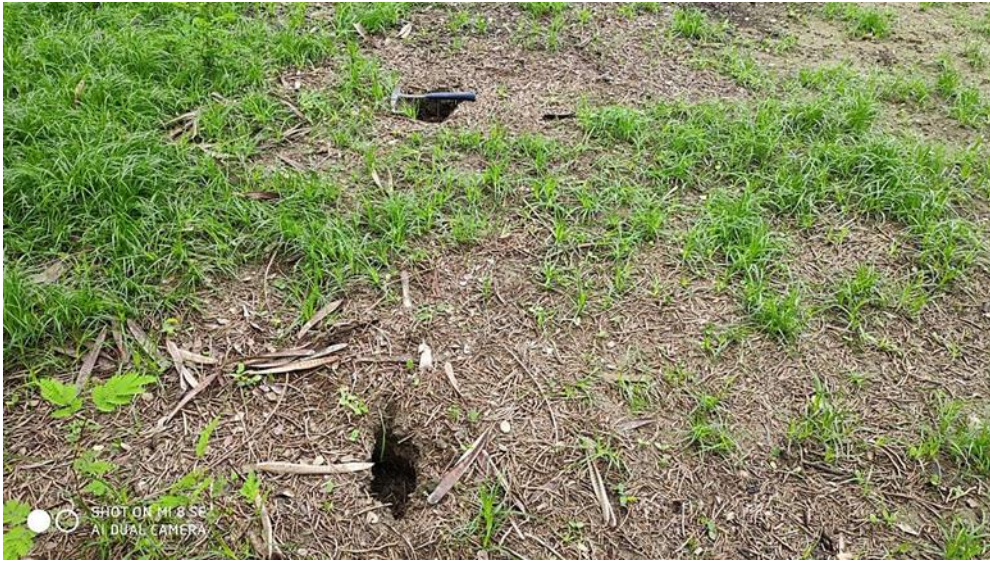
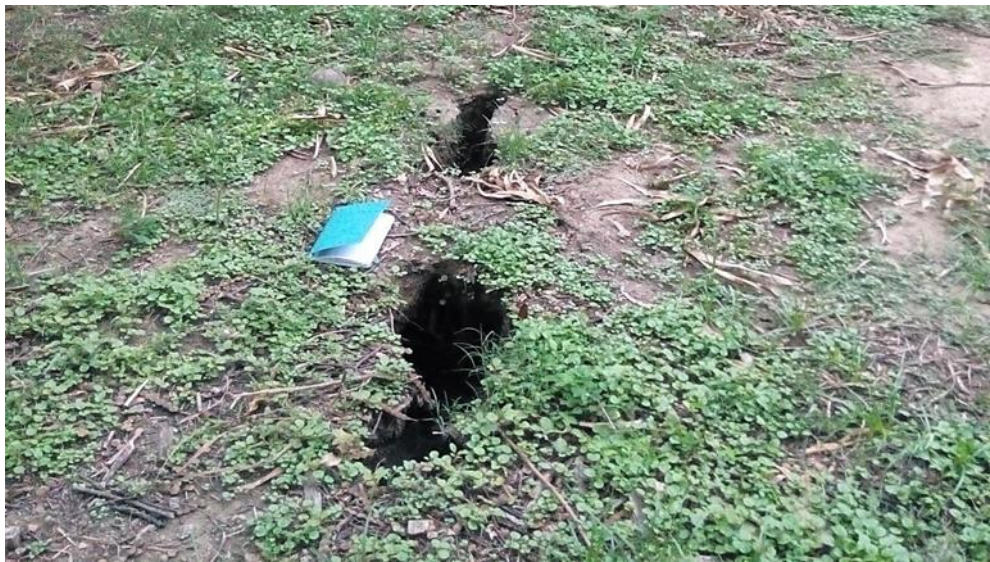
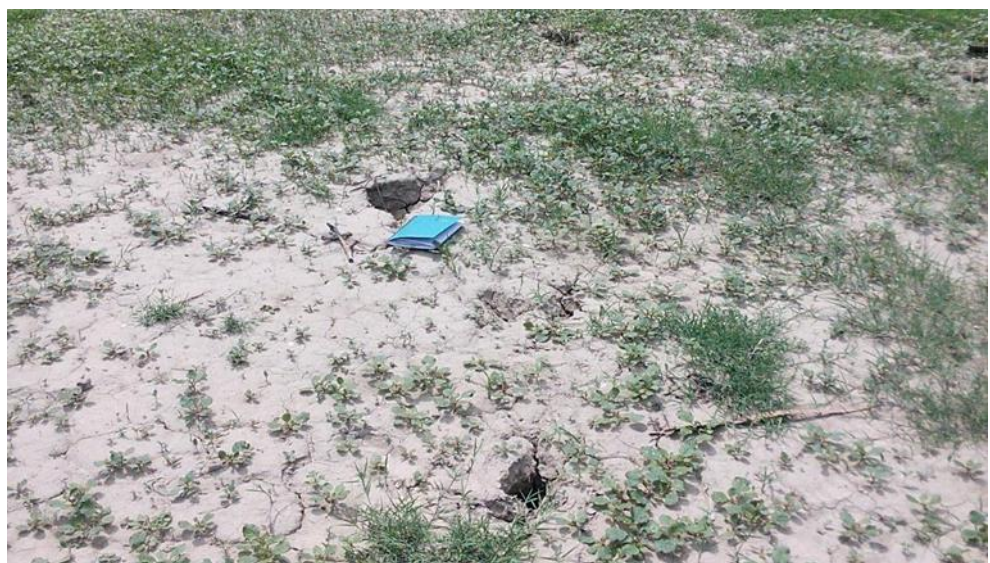
## Appendix 2. Sinkholes or piping conditions of study area
